# Manhole Inspection Summary

Manhole # S08YY1005MH

**Inspection** ☐ Is Incomplete Rating: **3) Fair**

**Location** Address: **4176 Crest Heights Rd**

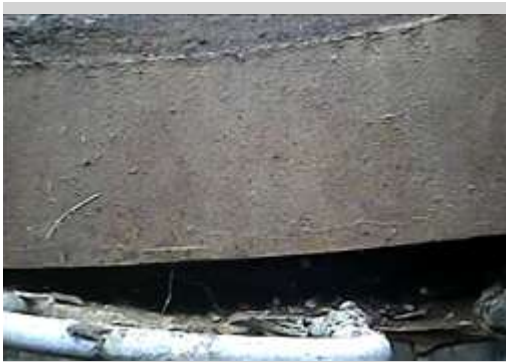
Defect

Condition: ☐ Sound ☐ Cracked ☐ Root Intrusion ☒ **Loose Brick** ☒ **Deteriorated**

Infiltration: ☐ None ☐ Joint ☐ Cracks ☒ **Mortar** ☐ Roots ☐ Wall

Loose/Missing Brick in adjustment

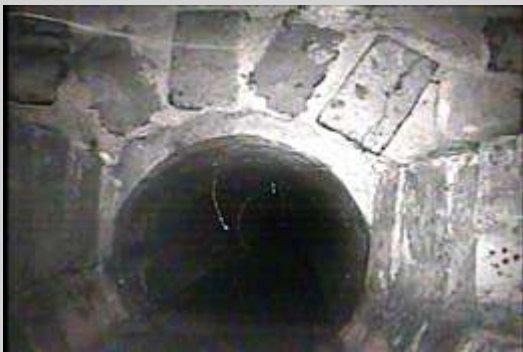
### 8 in. Circular Gravity Sewer Pipe Out @ 12 O'Clock

Pipe Material: **Clay** ☐ Pipe Lined

Invert Depth: **6.35** (ft.) Flow Characteristics: **Slow**

Deposits: ☒ None ☐ Mud ☐ Sludge ☐ Debris ☐ Grease

Infiltration: **None** Pipe Seal Cond: **Unknown**

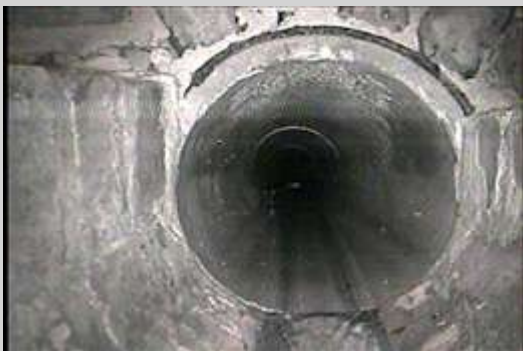
### 8 in. Circular Gravity Sewer Pipe In @ 3 O'Clock

Pipe Material: **Clay** ☐ Pipe Lined

Invert Depth: **6.09** (ft.) Flow Characteristics: **Slow**

Deposits: ☒ None ☐ Mud ☐ Sludge ☐ Debris ☐ Grease

Infiltration: **None** Pipe Seal Cond: **Unknown**

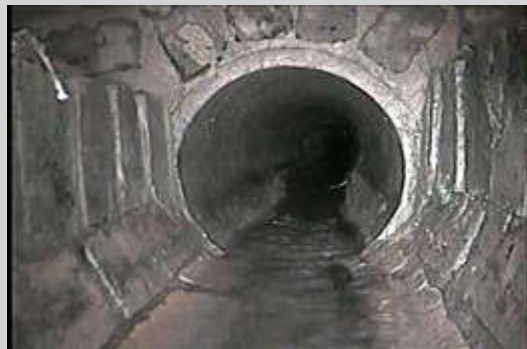
Pipe In @ 6 O'Clock

Pipe Material: **Clay** ☐ Pipe Lined

Invert Depth: **6.06** (ft.) Flow Characteristics: **Slow**

Deposits: ☒ None ☐ Mud ☐ Sludge ☐ Debris ☐ Grease

Infiltration: **None** Pipe Seal Cond: **Unknown**
